## Greek shipowner Cosmship Management achieves great results with HJ Mechtronic SIP

**Onboard the good vessel M/V "Nobility" equipped with MAN 6S46MC-C engine, the shipowner has experienced good cylinder condition and a significant reduction in cylinder oil consumption.**

**Cylinder condition – further reduction in feed rate recommended**

**Engine: MAN 6S46MC-C8.1 - ME load: 55% - Feed rate: 0.79 g/kWh – Sulphur in HFO: 1.5 – 2.5 %**

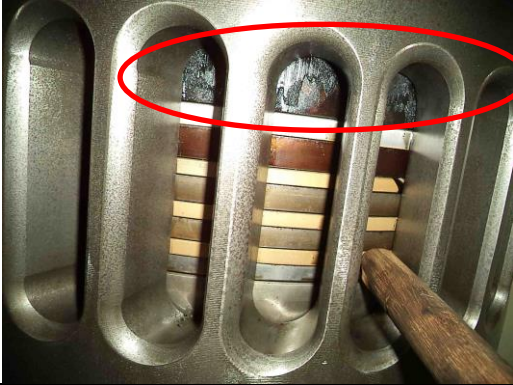
<p><b>Unit 2 – Piston rings and top land</b> Good condition of piston rings. Signs of overlubrication due to buildup of carbon residues.</p>	<p><b>Unit 2 – Liner wall</b> Good condition. Honing marks clearly visible.</p>

Condition of piston, piston rings and cylinder liner looks very good, however there is clearly signs of overlubrication as chemical residues are building up on piston top and top land. It is our recommendation that the feed rate is reduced. Below you can view pictures from unit #2, #4 and #5 which are representative for the whole cylinder condition.

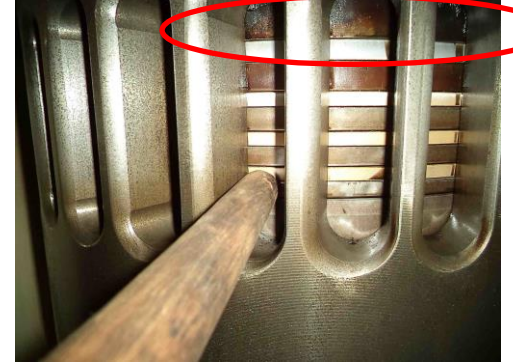
<p><b>Unit 4 - Piston rings and top land</b> Good condition of piston rings. Signs of overlubrication due to buildup chemical residues.</p>	<p><b>Unit 4 – Liner wall</b> Good condition. Honing marks clearly visible.</p>

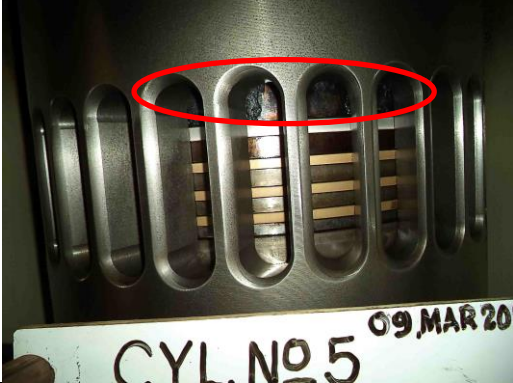
<p><b>Unit 5 – Piston rings and top land</b> Good condition of piston rings. Signs of overlubrication due to buildup chemical residues.</p>	<p><b>Unit 5 – Liner wall</b> Good condition. Honing marks clearly visible.</p>
