**CIMAC**  
**CONGRESS**  
HELSINKI | JUNE 6-10, 2016

## Lubtronic SIP promise remarkably low wear rates with low CLO consumption

05 Components & Tribology

### Peter Jensen, Hans Jensen Lubricators A/S

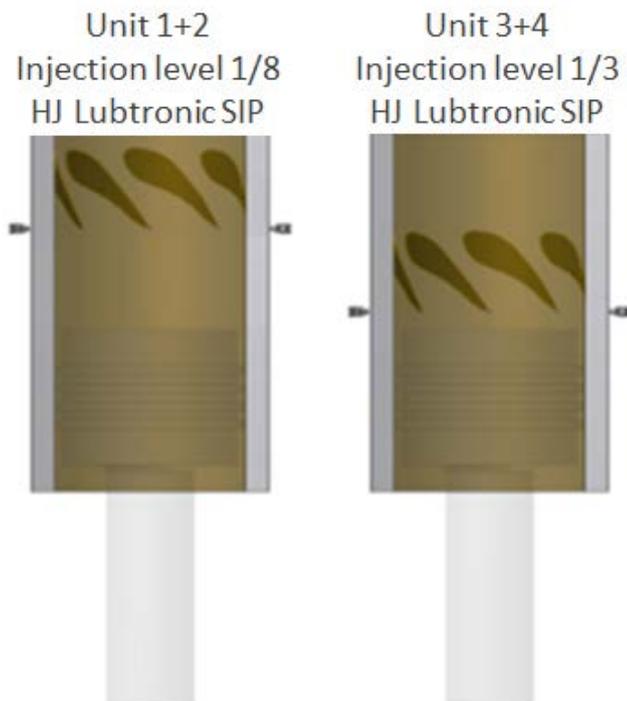
Figure 7: Setup of unit 1+2 & unit 3+4

**Unit 1+2** – These are equipped with HJ Lubtronic SIP. The injection level of the HJ SIP valves is for these units 1/8<sup>th</sup> of the stroke length from TDC, chosen by MDT. The use of the high level injection was a test from MDT, as it isn't standard lubrication level [4]. See Figure 7 for illustration of the setup.

**Unit 3+4** – These units are equipped with HJ Lubtronic SIP, with the SIP valves positioned 1/3<sup>rd</sup> of the stroke length from TDC which is the standard position [4]. Please see Figure 7 for illustration of the setup.

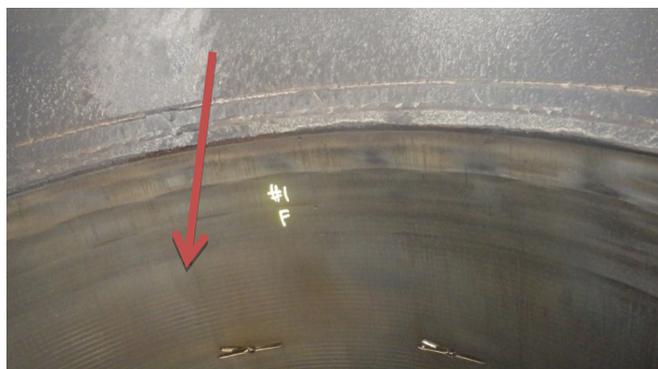
**Figure 10: Photo of liner number 1 after 10319 running hours – machining marks visible in the top**

**Units 1+2** - has lower maximum wear than the remaining units. These units have the lowest average wear rate in the engine. The wear rate is below half that of the reference units. The low maximum wear and the low wear rates on units 1+2 are confirmed by the photos taken inside the liner during the measurement where the liner machining marks still are visible. Unit number 2 is similar to the photo shown on Figure 10. The low maximum wear indicates that it is possible to lower the feed rate for these units, while maintaining low wear and cylinder condition. This was concluded at the attendance in July 2015 and also in January 2016 where the wear was so low that there was a risk of smirring. Therefore MDT recommended the vessel to lower the consumption for these units.

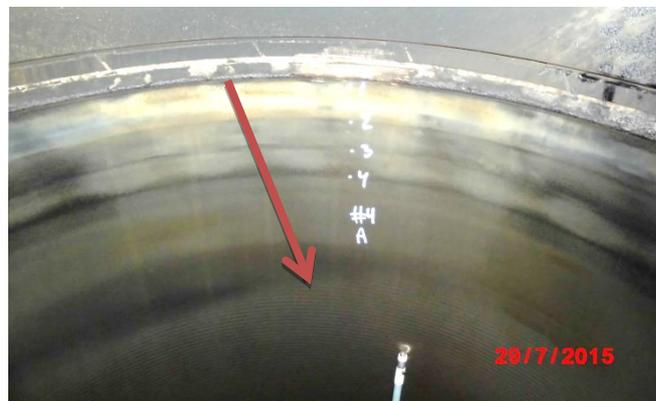
**Figure 11: Photo of liner number 4 after 9260 running hours – machining marks visible 300mm from the top**

**Units 3+4** - has the same level of maximum wear as that of the reference units. The units has low wear rate compared to the reference unit. It should be noted that these units had already seen the initial wear from alpha injection system when the HJ SIP injection valves was installed, therefore the initial wear has been deducted from the result of the wear rates on these units. Figure 11 shows unit number 4 after 9260 running hours. The low wear rates are confirmed by machining marks being visible from about 300mm and down. Liner number 3 is similar.

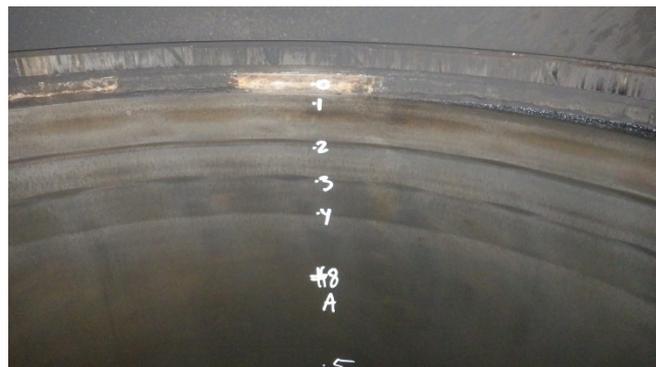
**Figure 12: Photo of liner number 8 after 4600 running hours – machining marks not visible**

Units 7+8+9 – Has a large deviation in the maximum wear, but all are below the recommended maximum wear from MDT. The units have half the wear rate that MDT recommends as the maximum wear rate, which is 0.1mm/1000h. The picture on Figure 12 shows unit 8 after 4600 running hours, this is similar to the remaining unit and the machining marks were worn down after 4600 running hours.

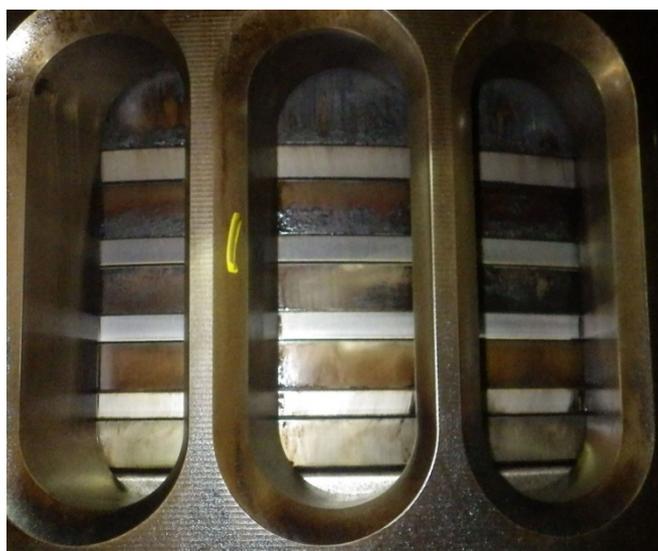
PISTON RING WEAR – The piston ring wear and condition on all units were good. The condition of the piston rings on unit number 1 can be seen on Figure 13.

Figure 13: Piston ring condition on unit number 1 after 10319 running hours.
